POLYROAD - YET ANOTHER ALTERNATIVE

INTRODUCTION

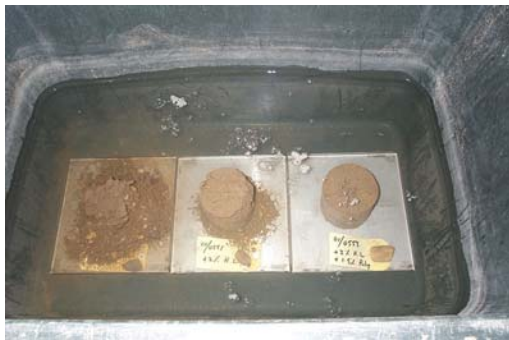
The samples were also placed in a tank of water to determine the effect of water under accelerated conditions. A photographic record was kept hourly for the first few hours then daily, then weekly, for about two months. The results were quite dramatic, with the untreated gravel/clay disintegrating within two hours and the lime treated gravel/clay dissolving a significant amount after about two weeks but the POLYROAD lost only a few grains of material and none of the strength over the two months and when removed from the tank, the water had only penetrated a few millimetres into the sample.

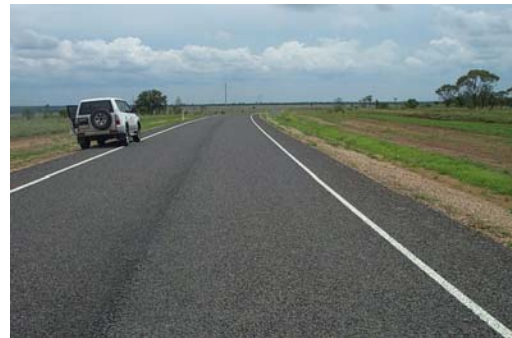
The trials using POLYROAD have proven the product viable and it is intended to continue trialling the material in selected locations to determine the most cost effective and best long term situations for the product life. The product has very great potential applications where we require a flexible pavement configuration while maintaining both wet and dry strength over a very long time period. It is intended to utilise the remaining material stored at the shire depot on similar repair work south of this project, once again on residual black CH clays.
